Brushy Creek Pool Finish Evaluation for Highland Horizon
Facility in Round Rock
March 16, 2026

March 16, 2026

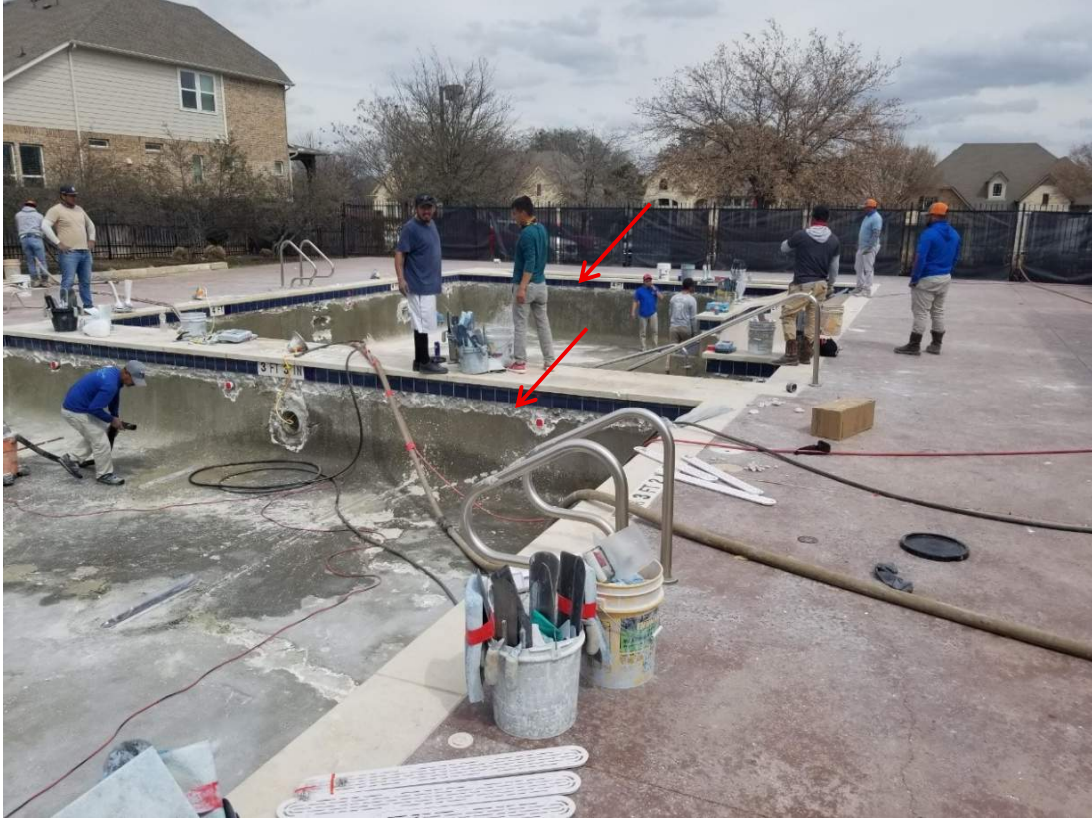
Photo No. 1 (2021)- Prior to plaster with bond coat applied. Rough chipped area under tile.

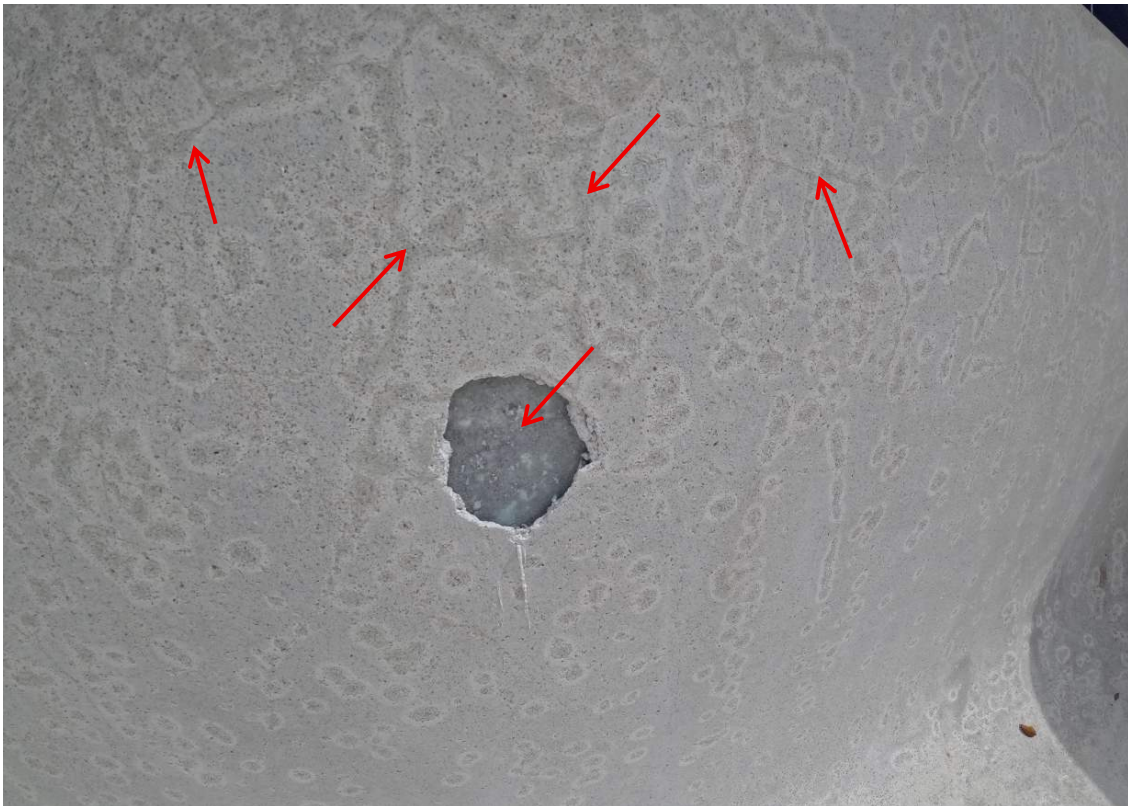
Photo No. 6 (2026) - This area had a thin bond coat and almost looks like epoxy on the wall. The spotting looks like it is pitting or spider cracks.

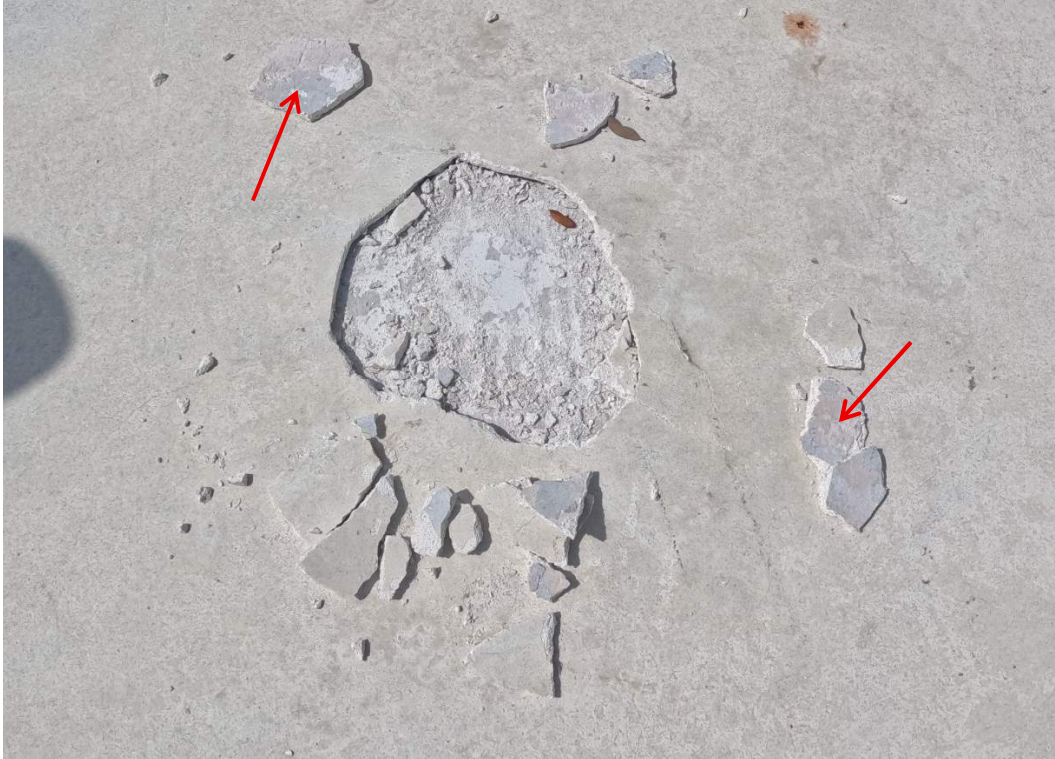
Photo No. 7 – This area looks to be both failure of plaster and bond coat together. (2026)
